Re: Reconnaissance Inspection, April 5, 2013
Condado Lagoon Sanitary and Storm Sewer System
Municipality of San Juan ("MSJ") Municipal Separate Storm Sewer System ("MS4") Permit
(PRR040036)
PRASA Puerto Nuevo Wastewater Treatment Plant Collection System (PR0021555)

**SUPPLEMENT TO WATER COMPLIANCE INSPECTION REPORT FORM
(EPA FORM 3560-3 (REV 9-94))**

CONDADO LAGOON SANITARY AND STORM SEWER SYSTEM

Inspection Date: April 5, 2013

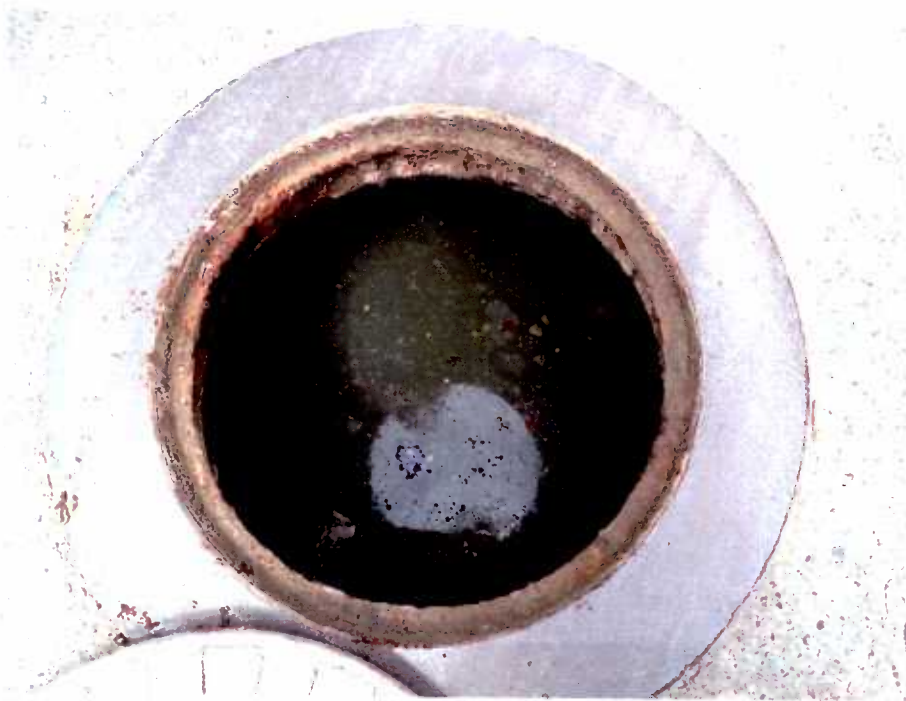
Photo 1

- 1) **Mayagüez and Aguadilla Streets (Northeast of the Condado Lagoon) Condado SSS:**
 - a. Wastewater manhole #1, Mayagüez and Aguadilla Streets Intersection at corner of Vanderbilt Lagoon #54. The manhole appears to be clogged or the line is overcapacity. It was observed filled with wastewater to an estimated depth of eight (8) inches below the manhole upper ring. (See photos #1 and #2).

Wastewater manhole #1

Mayagüez and Aguadilla
Streets Intersection at
corner of Vanderbilt
Lagoon #54

- i. **This area is considered a potential area of non-compliance that needs further investigation by both PRASA and the MSJ.**

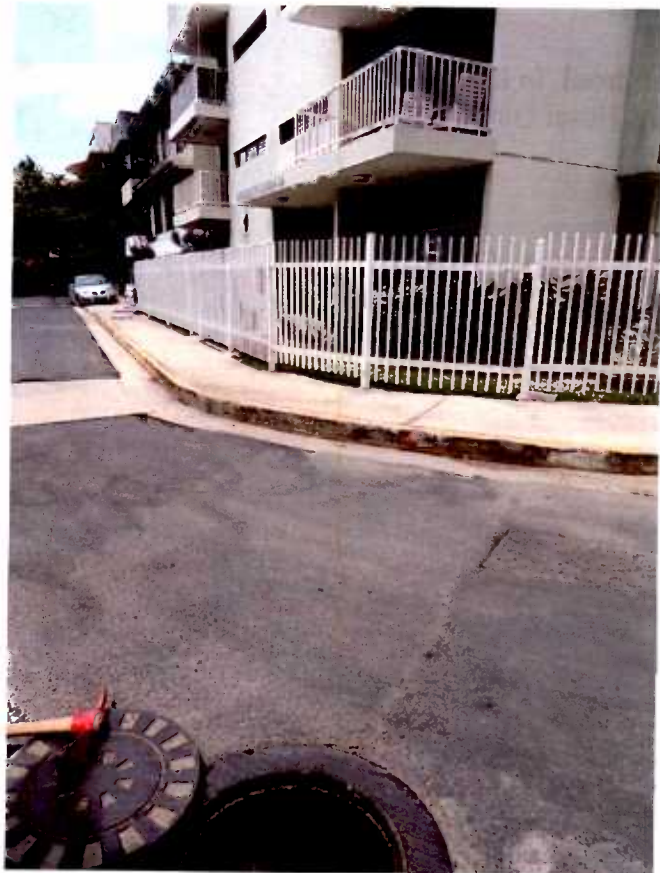
Photo 2

Partial view of wastewater
manhole #1

Mayagüez and Aguadilla
Streets Intersection at corner
of Vanderbilt Lagoon #54

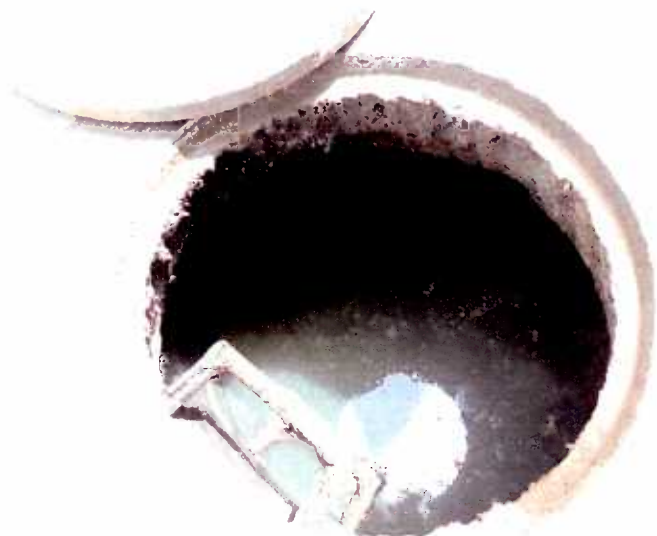
Photo 3

- b. Wastewater manhole #2, Aguadilla Street, in front of Restaurant/Hotel Olives. The manhole appears to be clogged or the line is overcapacity. It was observed filled with wastewater to an estimated depth of 8 inches below the manhole upper ring. See photos #3 and #4). Based on conversations with the residents, wastewater overflows at this point are common, not only during wet-weather, but also during dry-weather.

Wastewater manhole #2

Aguadilla Street, in front of
Restaurant/Hotel Olives

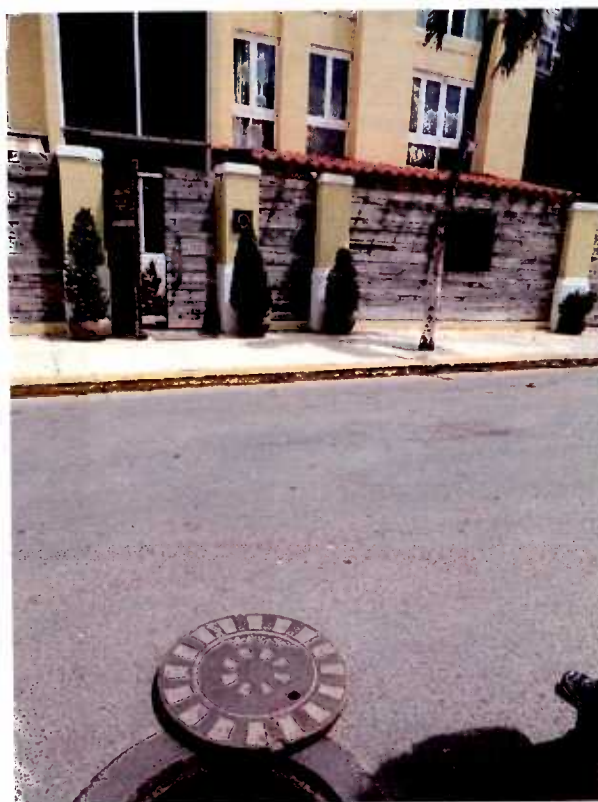
Photo 4

Partial view of wastewater
manhole #2

Aguadilla Street, in front of
Restaurant/Hotel Olives

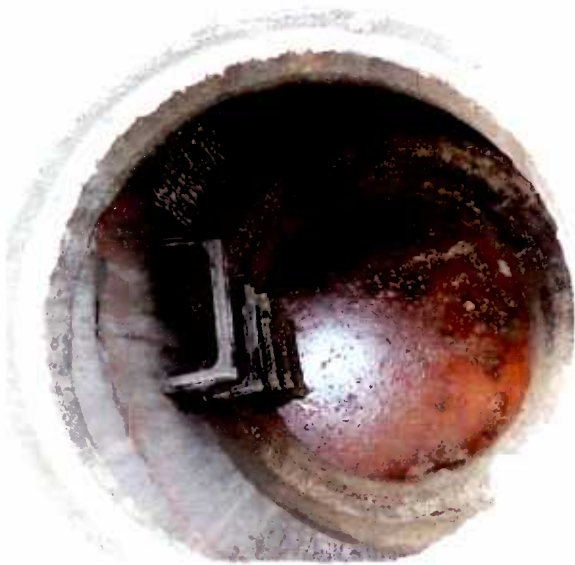
Photo 5

- c. Wastewater manhole #3, Aguadilla Street, in front of Esteban's Restaurant. The manhole was observed with high levels of solids, grease, and wastewater. The wastewater observed had an unusual orange color, and a strong grease odor, see photo #5 and #6.

Wastewater manhole #3

Aguadilla Street in front of
Esteban's Restaurant

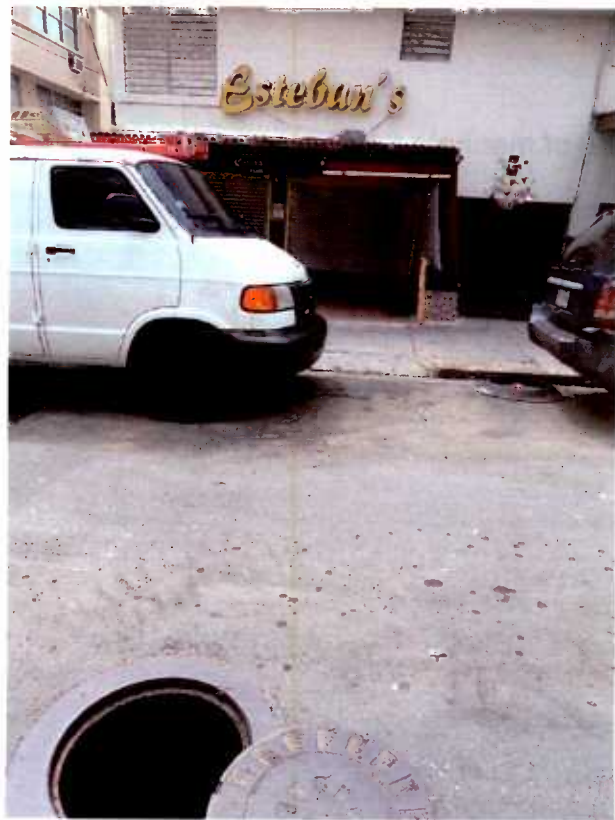
Photo 6

Partial view of wastewater
manhole #3

Aguadilla Street in front of
Esteban's Restaurant

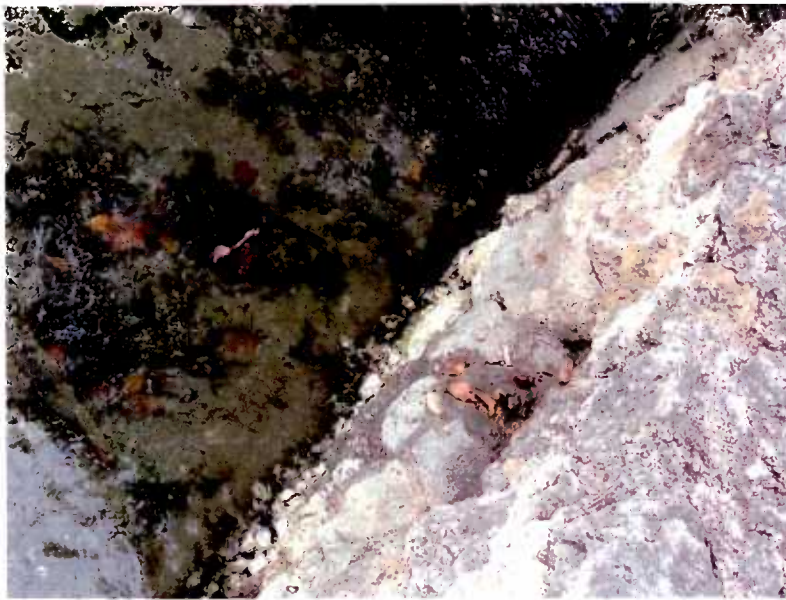
Photo 7

- d. PRASA's San Juan Operations personnel were also notified about the high levels of wastewaters in their sanitary pipelines in this area.
 - e. The storm water outfall in front of the Vanderbilt Lagoon #54 at Mayagüez Street was also inspected and no dry-weather discharges were observed during the inspection. See photo #7.

- i. **Mayagüez Street:** Coordinates: 18° 27' 27.46" N – 66° 04' 35.65" W. No dry-weather flow was observed at this outfall. See photo #7. **This is an area of concern that need to be monitored by MSJ, based on the apparent situation of recurrent overflows mentioned above at findings item #1.**

Storm water outfall at
Mayagüez Street in front of
Vanderbilt Lagoon #54.

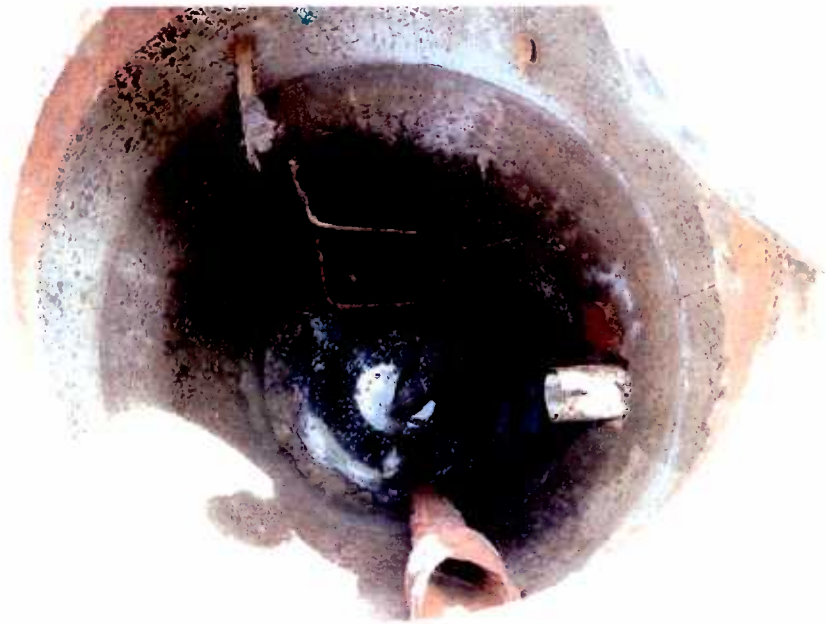
Photo 8

- f. A manhole structure (manhole #4) was observed at the walkway of the Aguadilla Street, in the corner of Esteban's restaurant. We need to know whether or not it is a sanitary or storm water collection system manhole. The inside of the manhole structure has a four (4) inch PVC pipe connection and another four (4) inch rusty pipe. In general, the structure is in bad conditions. See photo #8.

Partial view of manhole #4

Aguadilla Street, corner of
Esteban's Restaurant.

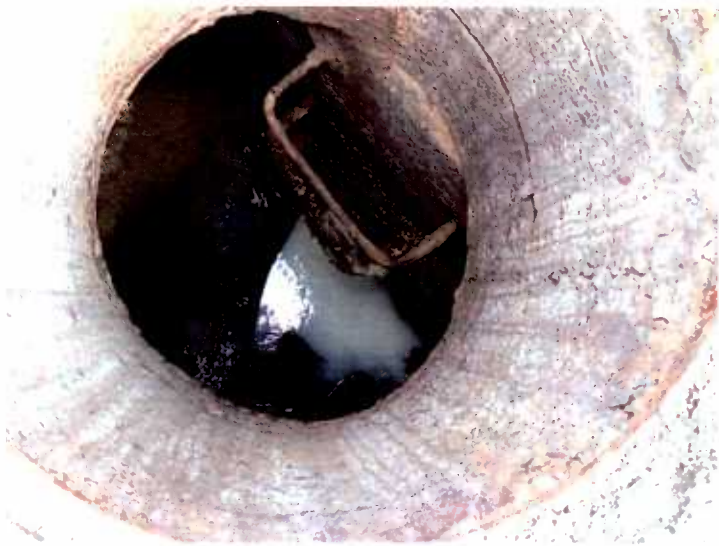
Photo 9

- g. Wastewater manhole #5, Aguadilla Street, in front of Colombo Bar and Restaurant. We observed a white colored flow, see photo #9 and #10.
 - h. The findings were referred to PRASA's Pretreatment Division, because the area has many restaurants in operation.

Wastewater manhole #5

Aguadilla Street in front of
Colombo Bar/Restaurant

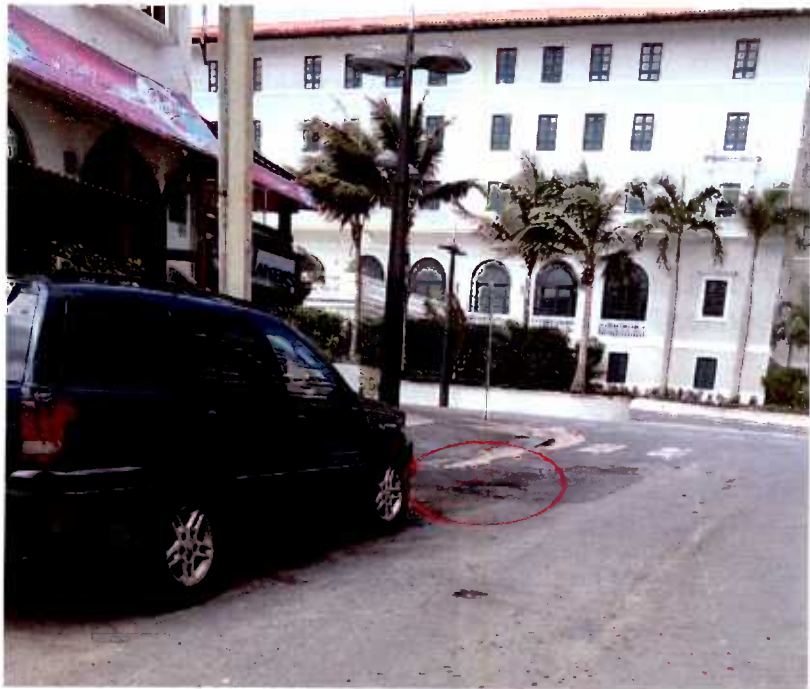
Photo 10

Partial view of wastewater
manhole #5

Aguadilla Street, in front of
Colombo Bar/Restaurant

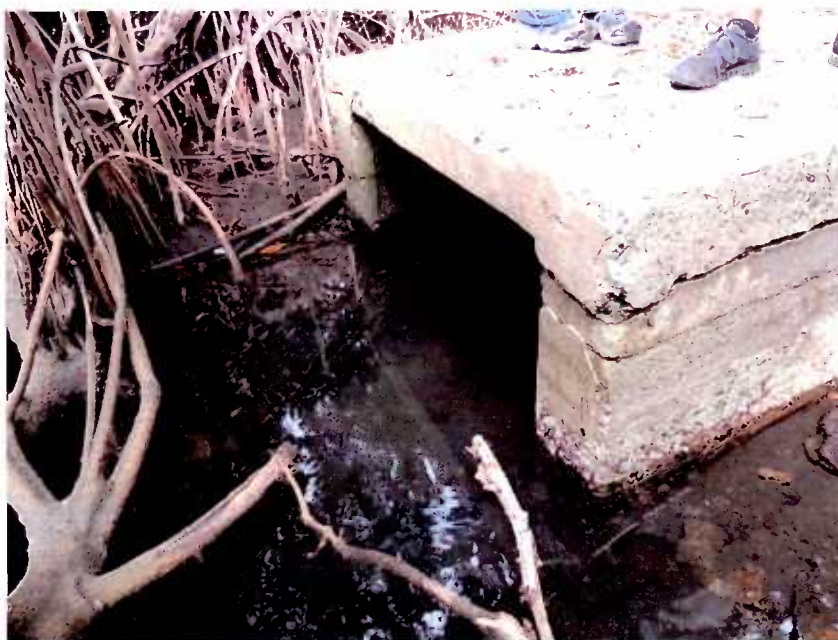
Photo 11

- ii. **Concrete rectangular storm water discharge structures near the end of Vieques Street and Jaime Benítez Park parking lot:** Coordinates: 18° 27' 18.08" N – 66° 04' 30.01" W. Two (2) rectangular storm water structures were found. Turbid and grayish water flow was observed in both structures. One of the structures has approximately 36 inches of width and the other at least 72 inches wide. See photo #11 and #12. **This is a potential non-compliance point of discharge of pollutants that needs further investigation by MSJ.**

Storm water discharge
structure

Near end of Vieques Street
and Jaime Benítez Park
parking lot

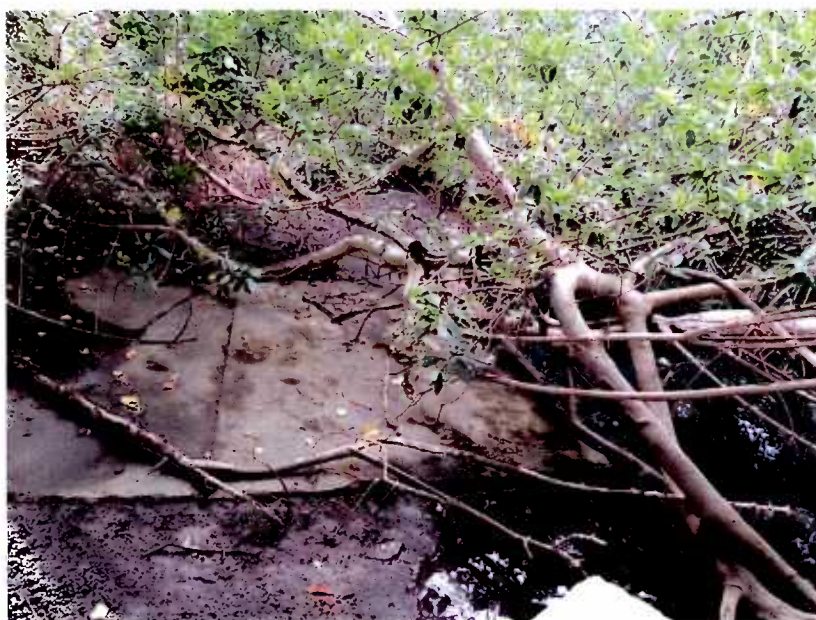
Photo 12

Storm water discharge
structure

Near end of Vieques Street
and Jaime Benítez Park
parking lot
